TESTING A HATCHBACK TYPE PASSENGER CAR FIRE

Anna SZAJEWSKA¹

Review article

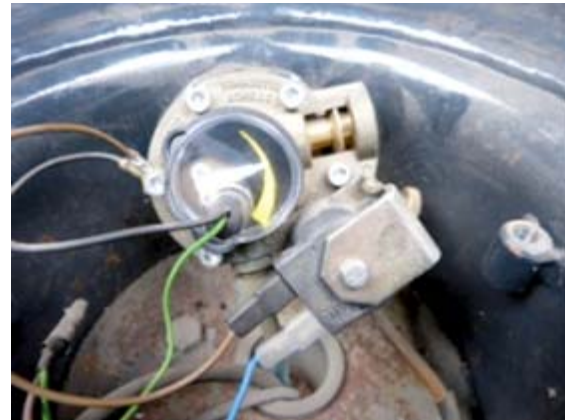
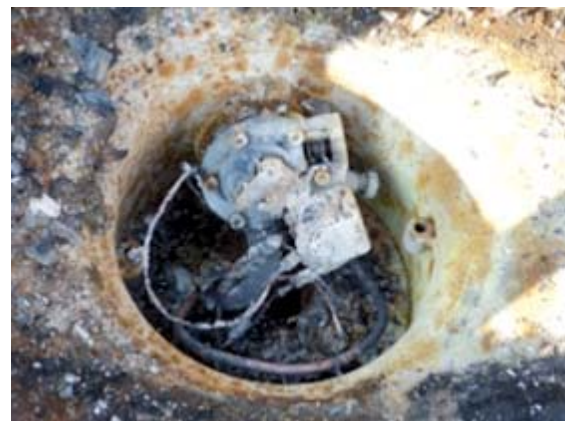
The LPG tank in the gas system is equipped with a multivalve that fulfils several functions, one of which is assuring safety during a car fire (Fig. 2). It becomes activated once the pressure achieves the value of 2.7 MPa. In such case gas permeates under the car via special venting ducts provided in the multivalve housing. The bursting pressure of the

tank is 6.75 MPa. The multivalve contains a fuse valve, which becomes activated when temperature of the tank mantle reaches the value of 110°C.

Fig. 2 Multivalve of the LPG tank before and after combustion

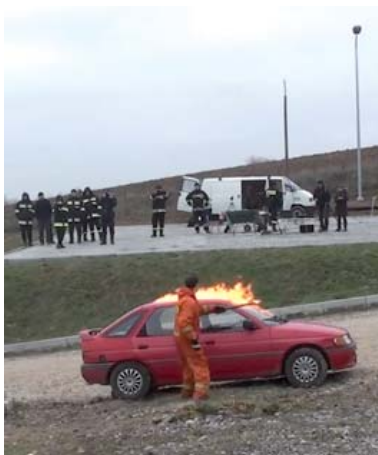
The fire was initiated by pouring one litre of petrol onto the car roof and igniting it with a torch (Fig. 4). This was meant to simulate arson using a “Molotov cocktail”.

Fig. 4 Setting the Ford Escort car on fire.
The measurement stand in the background

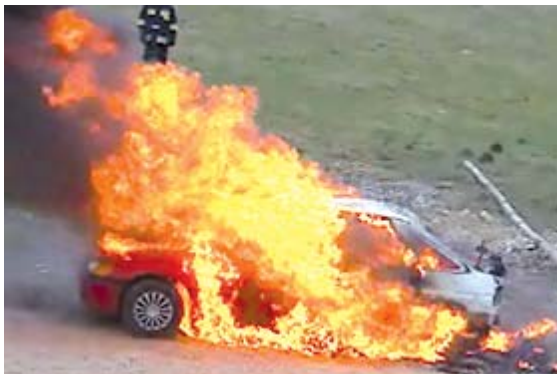
- o) 22:30 Leak of fuel from the tank (Fig. 5). Burning fuel induced a rapid temperature growth in the passenger cabin and quick spread of the fire to the engine compartment.

Fig. 5 Photograph of a vehicle after fuel leak from the tank

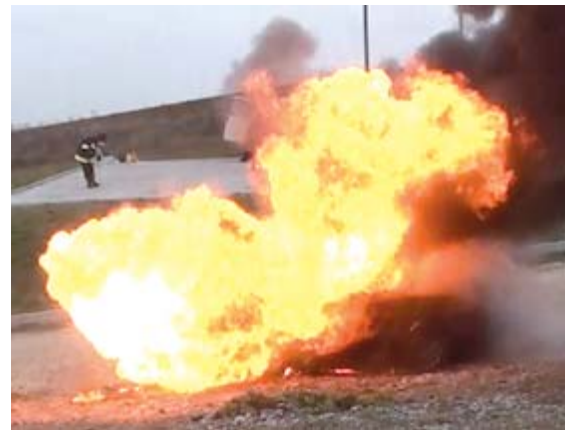
- p) 23:00 Explosion of right rear shock absorber.
- q) 24:15 Rapid spreading of the fire to the engine compartment.
- r) 24:40 Triggering safety valves and emission of a burning gas flux (Fig. 6). This induced a temperature increase in the passenger cabin to the maximum value. The gas was released for approximately 1.5 minutes. Activation of the valve took place during a rapid temperature increase from approximately 150°C to approximately 650°C, which was measured by a thermocouple attached close to the LPG tank (Fig. 7).

Fig. 6 Ignition of gas released from the LPG tank

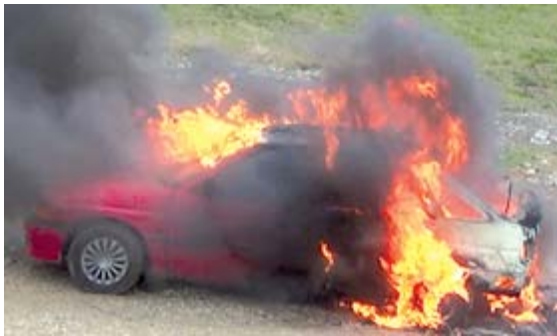
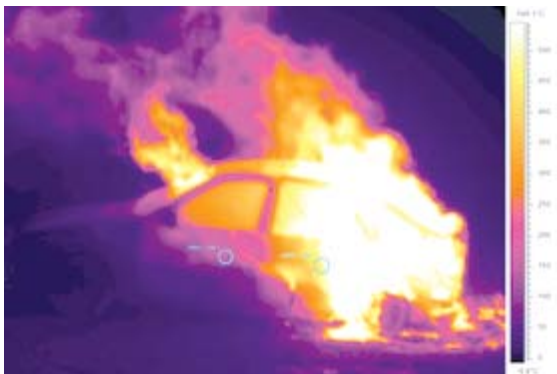
The infrared camera was used to monitor the combustion process as supplementing of a digital camera, because certain details are better visible in infrared than in the visible light. This is especially applicable to observations made in smoke logging and in the darkness. In Fig. 9 smoke impedes observations of the front car door. They are, however, well visible in infrared.

Fig. 9 Photograph of a car and a thermogram of the car body surface. At the measurement points marked on the thermogram, the average temperatures were: 158.1°C and 495.7°C
