TESTING A HATCHBACK TYPE PASSENGER CAR FIRE

Anna SZAJEWSKA¹

Review article

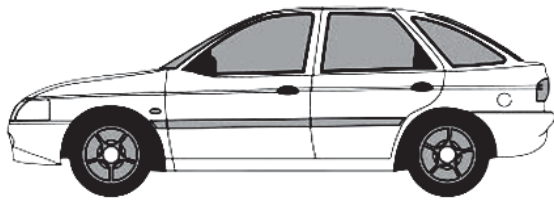
Fig. 3 Arrangement of thermocouples

Five thermocouples were arranged inside the vehicle and two more on the car body surface (Fig. 3):

- 1 - in the passenger cabin under the ceiling,
- 2 - in the passenger cabin on the floor,
- 3 - in the engine compartment over the engine,
- 4 - inside the boot,
- 5 - inside the boot compartment close to the multivalve of the LPG tank,
- 6 and 7 - on the car body surface.

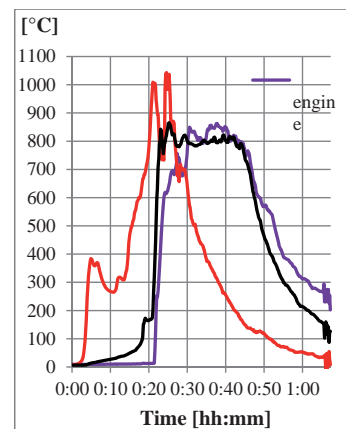
Fig. 7 Diagrams of temperatures during combustion of a Ford Escort for selected places: in the passenger cabin under the roof and on the floor, and in the engine compartment over the engine

- p) 23:00 Explosion of right rear shock absorber.
- q) 24:15 Rapid spreading of the fire to the engine compartment.
- r) 24:40 Triggering safety valves and emission of a burning gas flux (Fig. 6). This induced a temperature increase in the passenger cabin to the maximum value. The gas was released for approximately 1.5 minutes. Activation of the valve took place during a rapid temperature increase from approximately 150°C to approximately 650°C, which was measured by a thermocouple attached close to the LPG tank (Fig. 7).
